Honeywell Thermal Interface Materials Evaluation Report

HLT3000

Vibration result – Thermal Performance

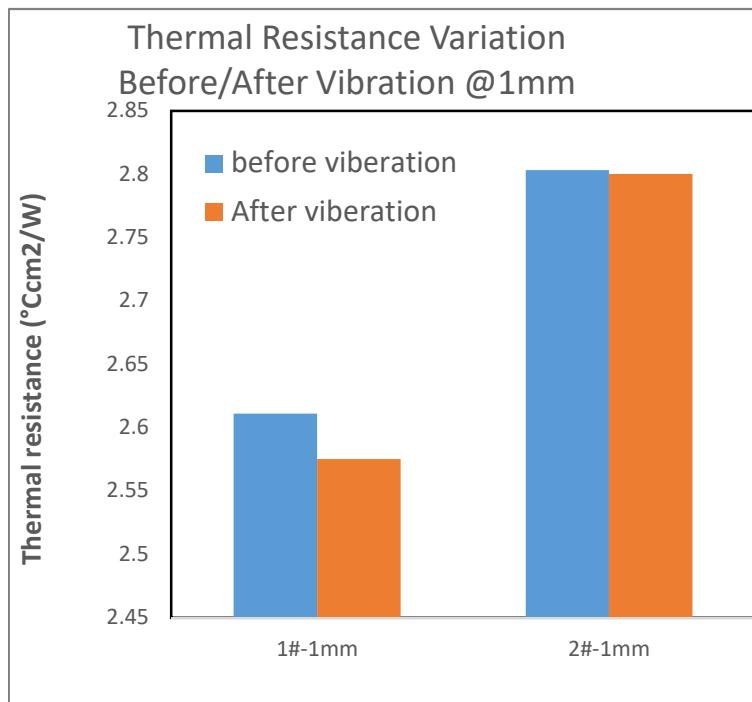
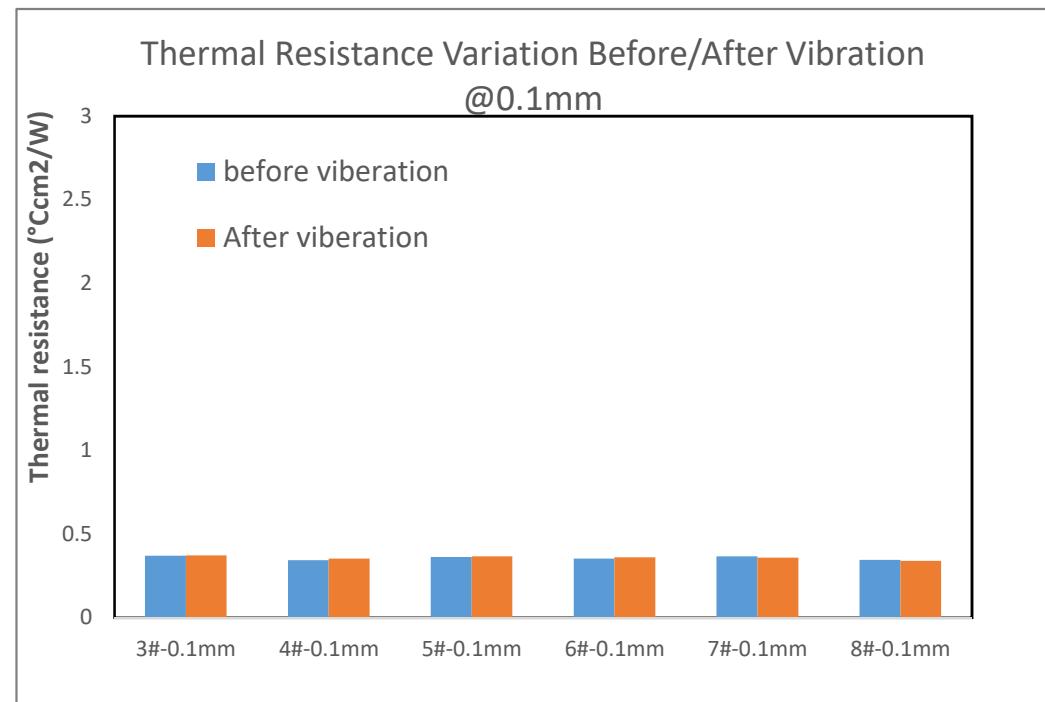
* Test Method: ASTM-E1461

Result: HLT3000 thermal performance keep stable after vibration test under varies of thickness

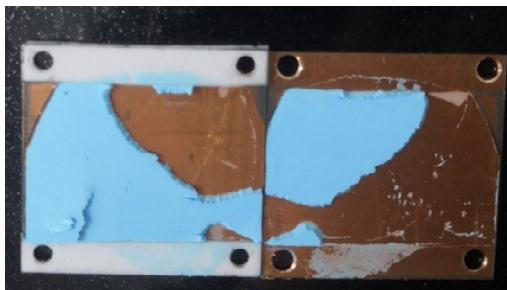
1mm Thickness Sample

Result: HLT3000 has no oil bleeding after vibration test

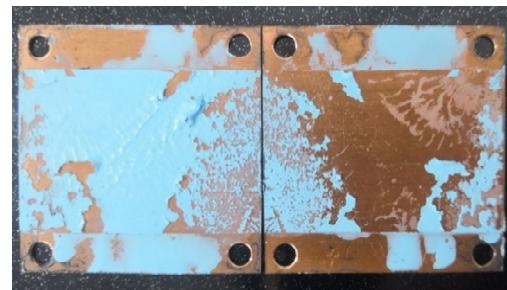
0.1mm Thickness Sample

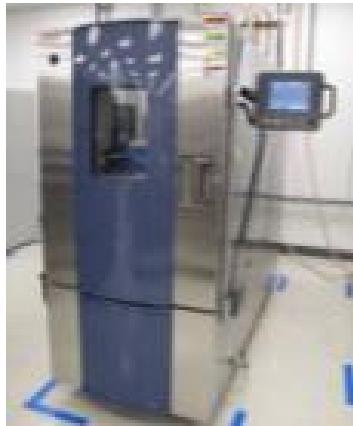
TC chamber

Standard: JESD22-A104C

Testing Condition: -55°C to 125°C (TCB), 1000cycles

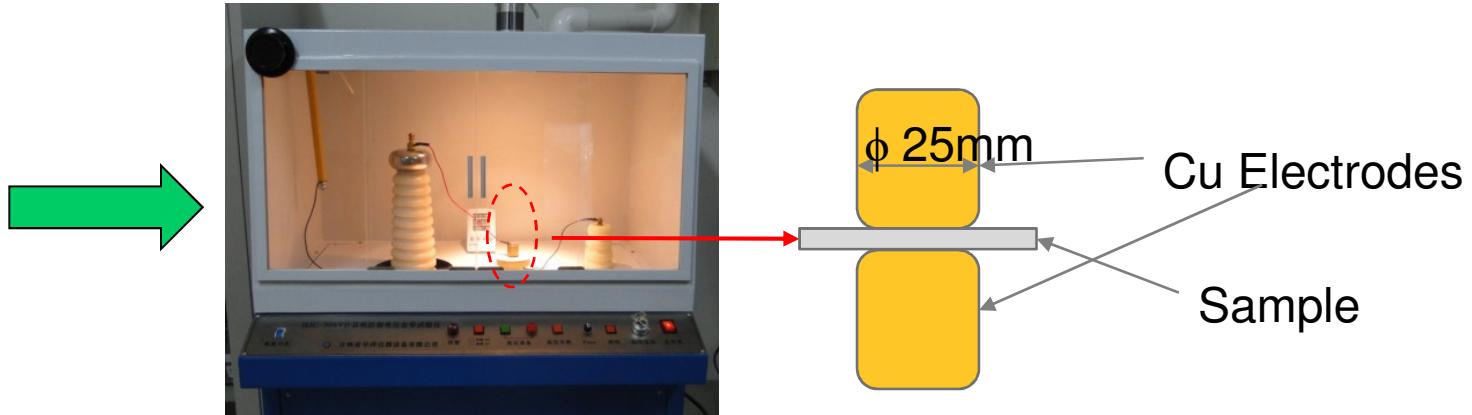
Dielectric strength tester HJC-10KV

Electrode size: φ25mm X25mm

Rate of AC voltage raise: 0.1kV/s

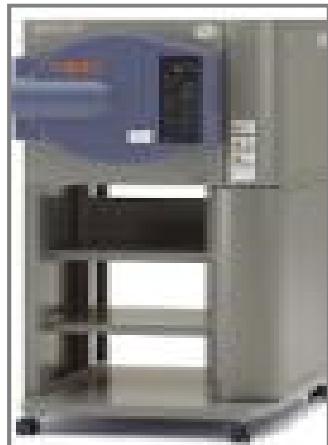
HAST chamber

- Testing Condition: 85°C, 85%RH, **96 hours**
- Put test sample in D85 chamber and compare the weight before/after test to evaluate if moisture absorbed in sample

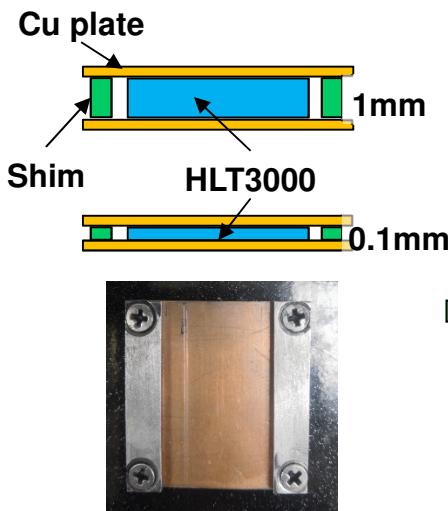
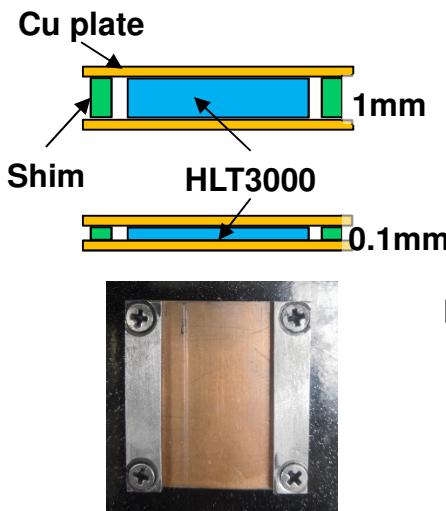
Sample preparation

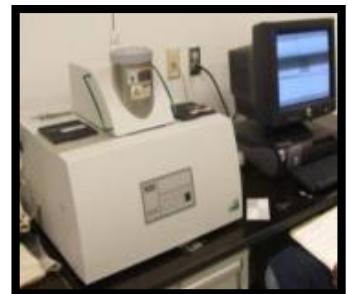
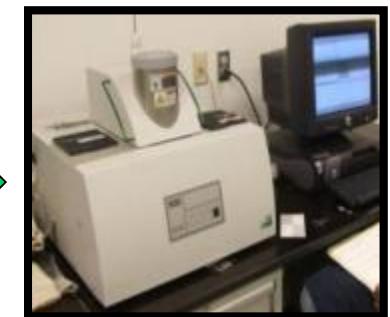
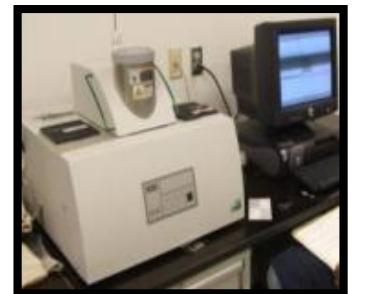
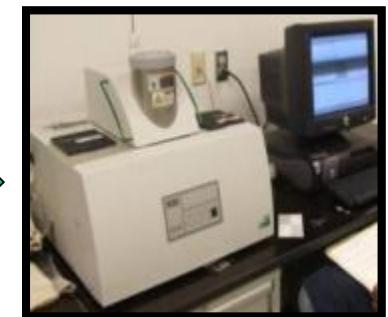
Thermal resistance test

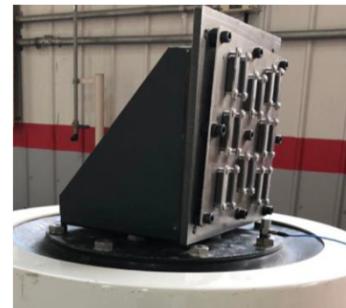
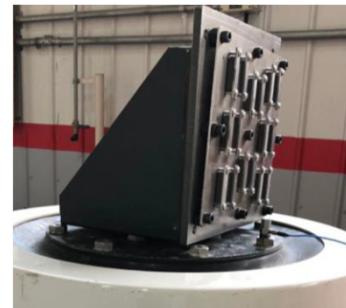
X, Y, Z vibration
